ADA MERCURY HYGIENE RECOMMENDATIONS A REVIEW

*Bhumija Maharishi Trivedi

This article reviews and elaborates on the ADA's 11-point mercury safety guidelines. Common workplace violations are highlighted, and steps for correction are cited. Practitioners can utilize this information to assist in development of an office protocol.

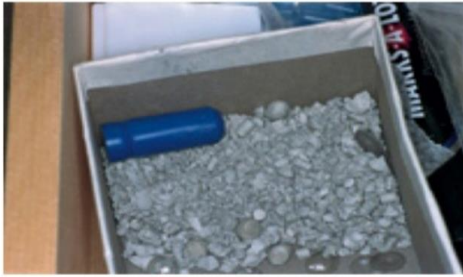
Figure 1. Scrap amalgam improperly stored in an unsealed open box, within a treatment room drawer. Also note the open spent amalgam capsules, which actually are of minor consequence in this unsafe and noncompliant situation.

Some dentists improperly store scrap amalgam in open containers (Figure 1). Used amalgam-mix capsules containing small amounts of amalgam are sometimes improperly stored in an open, and not closed, manner. Waste amalgam and spent capsules may be inappropriately disposed of in the general office refuse, from which they later enter municipal landfills or incinerators. This source of mercury can enter ground water, or elevate the mercury level in the air.^[19,20] Adherence to ADA Recommendation No. 11 on methods for amalgam storage is advisable. (See discussion of Recommendation No. 11 later.)

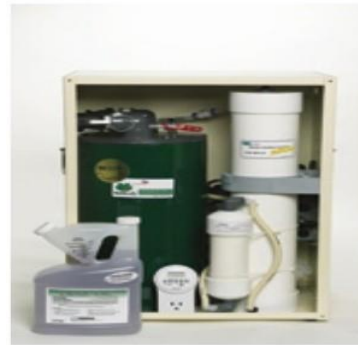
Figure 2. ISO (International Organization for Standardization) 11143 certified amalgam separator. These units protect municipal wastewater by collecting the 60% of waste amalgam and mercury that bypasses standard dental unit primary and secondary traps.

The Vermont Dental Society and the National Wildlife Federation have jointly published guidelines for environmental safety.²¹ Special amalgam separator/ collector traps have been designed for dental wastewater. These are required in Germany, King County (Seattle), Washington, and many other regions.^[22] These separators have been specially engineered to remove elemental mercury and very small particulate amalgam, which will pass thorough standard dental operatory unit traps.^[23,24]

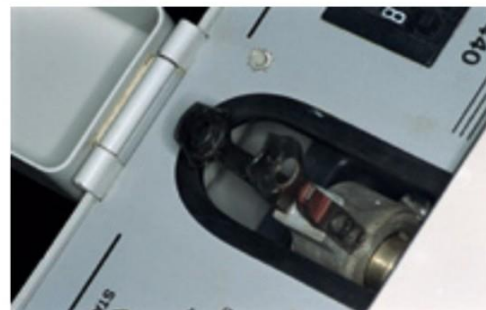
Figure 3. Internal floor surface of amalgamator (assuming no defective open seam) has collected scrap amalgam and beads of elemental mercury. Over time, amalgamators become contaminated to the degree of a biohazard. They represent a source of mercury vapor for dental personnel.

Mercury-contaminated amalgam at or present another problem (Figure 3).^[25,26] Debris on any surface or working part of an amalgamator may include scrap amalgam, as well as beads of free mercury. A defective gap or seam opening will permit debris to escape from the amalgamator. Otherwise, risk is limited to mercury vapor exposure directly from the contaminated amalgamator.

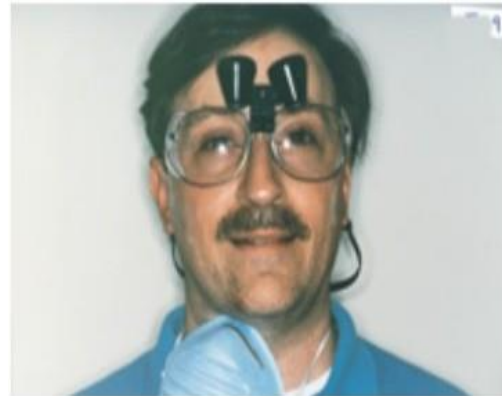
Figure 9. Clinician with protective eye wear, protective clothing, and surgical facemask.

Facemask must secure to facial contours including facial hair. No standard mask will filter mercury vapor or amalgam particulates smaller than 10 µm. Filtration protection varies for different masks.

Unfortunately, standard barrier techniques do not prevent pulmonary exposure to mercury vapor (Figure 9). The filtration pore size and a secure mask seal vary greatly from manufacturer to manufacturer with standard surgical masks.^[30] Some masks are far superior to others in filtering waste amalgam

particulate material. Masks should be changed frequently to assure effectiveness. No standard surgical mask can filter mercury vapor or amalgam particulate matter smaller than 10 μm .³¹ A poorly fitted mask, or one from an inferior manufacturer, will fare far worse. Several studies have examined the quantitative release and consequences to dental personnel of mercury vapor sourced to amalgam removal.^{32,33} Few research the problems of μm -sized amalgam particles, which have potential to travel through protective masks, and ultimately into terminal alveoli of the lungs.^[31]
